Failed Subsea Well Production Recovered Using Stratacoil™ Through-Tubing Screens

Location
Troika field, Gulf of Mexico

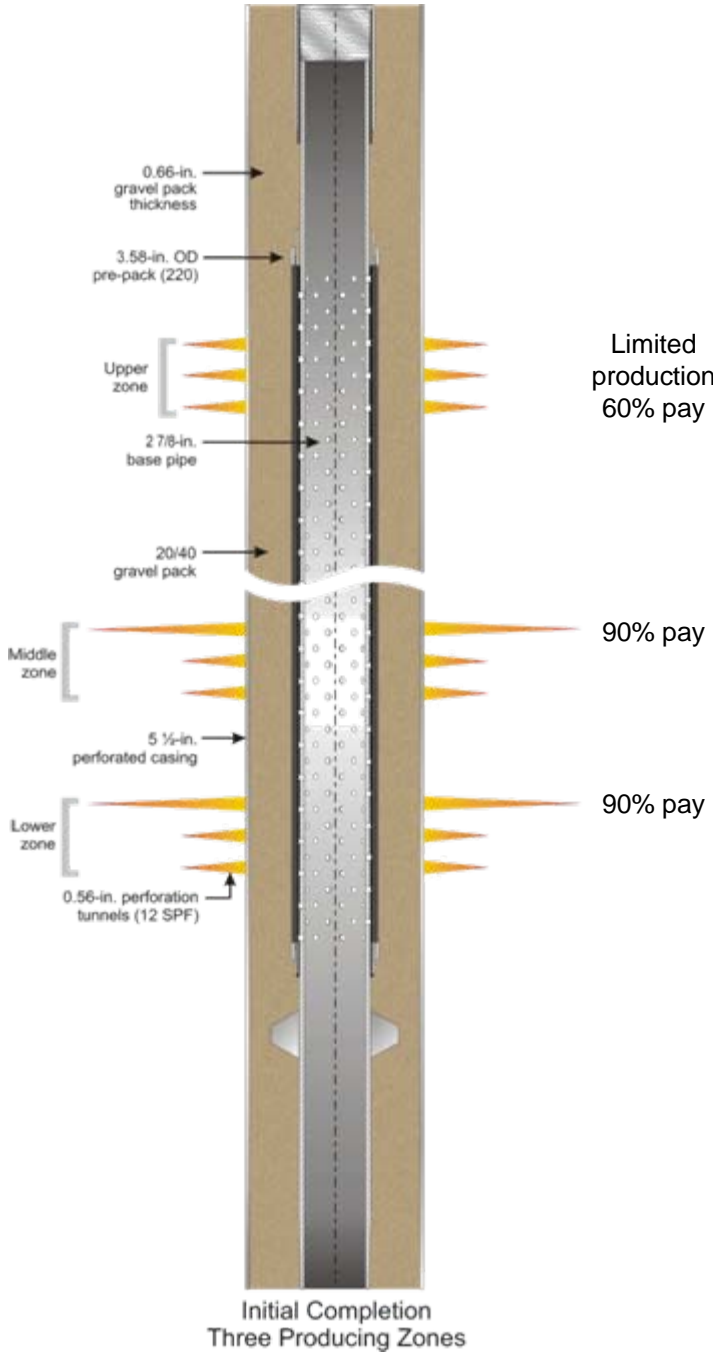
Initial GoM Cased-Hole Gravel Pack

- Recover the remaining oil and gas reserves of a well that had failed after 14 months with massive sand production. Screen gap velocity likely exceeded 3 ft (1 m)/sec.
- Minimize recompletion cost, and maximize production string size.
- Install a barefoot completion to directly retain very fine, non-uniform sand.
