MetalSkin® Solid Expandable Cased-Hole Liner System Successfully Deployed from Semi-Sub

North Sea, Norway

CO₂ injector

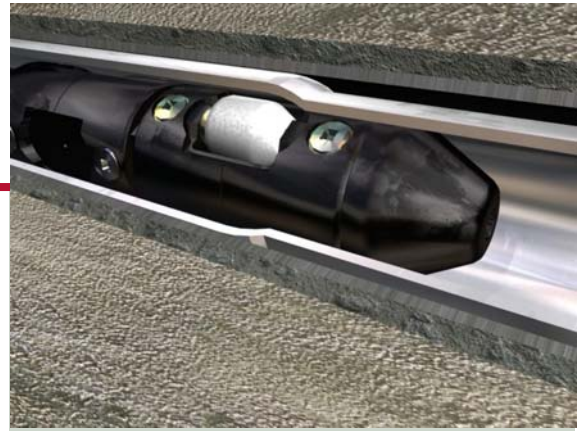
The *MetalSkin* cased-hole liner is a fully expandable casing repair system that provides a maximized throughbore and a compliant fit to corroded or worn casing.
