Permanent Tubing Patch, Rigless Well Integrity Diagnostics Restores Oil Production in Two Wells, Saves CAPEX of \$3.8 Million USD

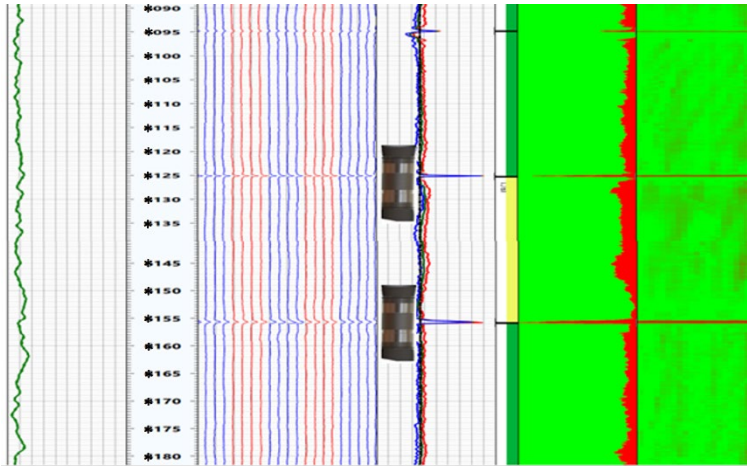
MFC data interpretation plot showing the leak points and installed patches against accordingly.

- The first challenge were the leak points. They were situated across the collars in one of the wells and it was challenging to properly identify them. After a detailed study of the 3D/3D tubing images and views and the outputs from the injection logging, the Weatherford IES team identified the leak points.
- The Weatherford team turned its attention to the second challenge: determine the viability and effectiveness of running the tubing patch in both wells before running in hole and installation.
- The solution involved using a detailed corrosion analysis across the joints of interest to check the tubing metal loss and ovality. The team deployed an ISO EasySet setting tool which operates via e-line communication from the surface. It provided a slow setting sequence to the tubing patch for safe and accurate installation.
