UltraView™ Tool Accurately Determined Effectiveness of New Perforations System in Deviated Injector Well

LOCATION
Meta, Colombia

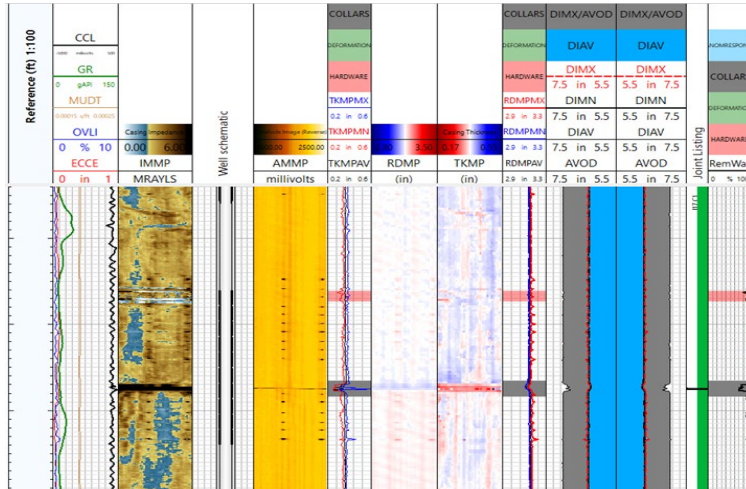
UltraView log with the following information obtained: amplitude map, thickness measurement, radius readings, and a calculation on the length and height of the connectivity points.

- The dimensions of the new window (length and height) were 1.6 x 0.7 in. (40.6 x 17.7 mm).

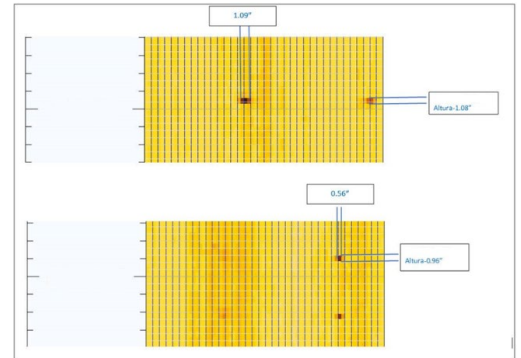
- The well integrity analysis identified that the hydromechanical connection left an internal mark at the desired depth.
- Tool thickness measurements showed that the casing was not open per the customer requirements. Additional integrity tests confirmed that the test of the technology wasn't working.
- Internal investigation by the customer was performed and part of the probes were the casing analysis and surface pressure test performed that didn't show any change.
- To complement the information and the analysis, it was essential to compare dipole sonic log (cross dipole) and neutron from before and after performing the hydromechanical operation.
- This was the first time the operator was trying this new technology and they trusted Weatherford to accurately identify the new perforation system.

Length and height of the internal marks left initially by the hydromechanical system.

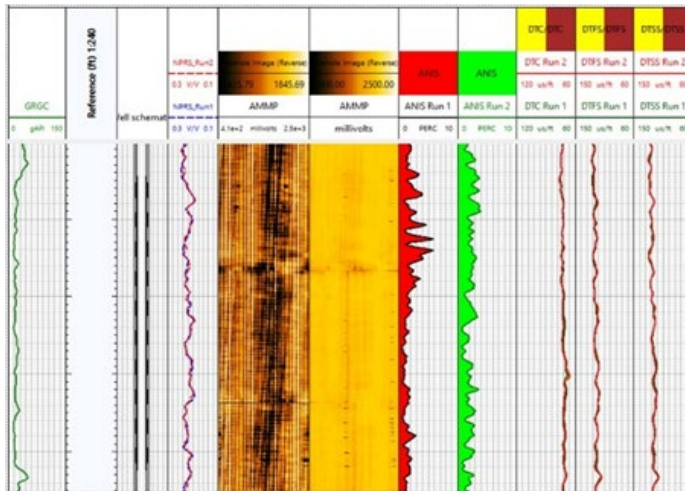
Plot that shows the amplitude map from the UltraView tool where the windows form the hydromechanics system, and comparison amyotrophy and neutron reading.
