Advanced Well Integrity, Reservoir Monitoring Analysis Identified Leak Zones Stemming from Corrosion, Avoided Catastrophic Blowout

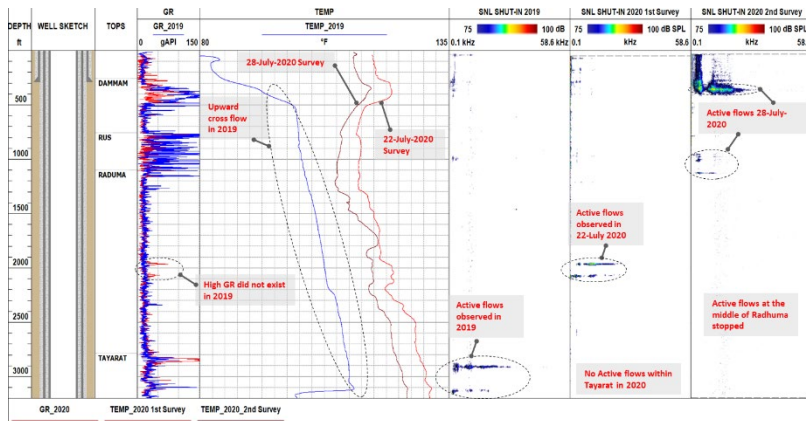
The SNL-HPT comparison, 2019 vs. 2020 (1st: 22 July and 2nd: 28 July)

- Field personnel ran different reservoir monitoring and well integrity logs: MIT, URS, MTD, a corrosion tool, and a SNL-HPT.
- Weatherford's Interpretation and Evaluation experts analyzed the data and confirmed the presence of gas inside different formations that migrated from a lower formation due to corrosion and a poor cement job.
- In 2020, a well integrity analysis was conducted as per the maintenance schedule. The result of the first logging run indicated the fluid flow originally observed in 2019 was still present and the root causes of the flow were identified.
- A remediation plan was developed to resolve the issues identified. After the remediation activity was completed, a second logging run validated that the undesired fluid flow was eliminated. The second logging pass confirmed the remediation activity met the customer objectives and the well could be returned to service.
