CalView® Tool and TVision Software

Enable Deepwater Well Completion, Avert \$200 Million Cost Sidetrack

LOCATION
US GOM

WELL TYPE
Deep water, sub salt

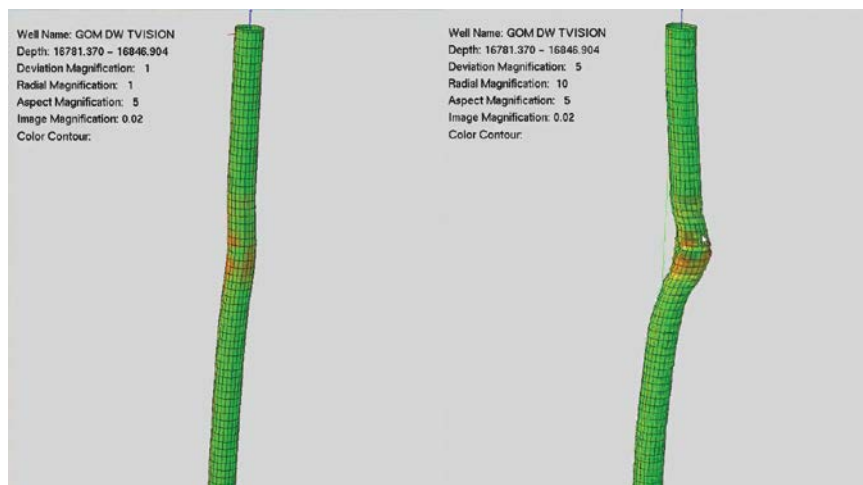
The slightest issues in the metal integrity, such as this casing shift (left), will be detected by the CalView service. The CalView service magnifies the problem (right) for improved clarity.

- Weatherford logged the well with the CalView tool and obtained data revealing that the casing had shifted within the salt section of the well for an unknown reason.
- Analysis of the data by Weatherford Interpretation & Evaluation Services (IES) indicated that the overall integrity of the casing had not been compromised.
- IES analysts worked with the operator to run multiple drift diameter scenarios that provided a realistic image of the downhole situation. The client was able to determine that the packer originally chosen for the completion would not fit through the buckle.

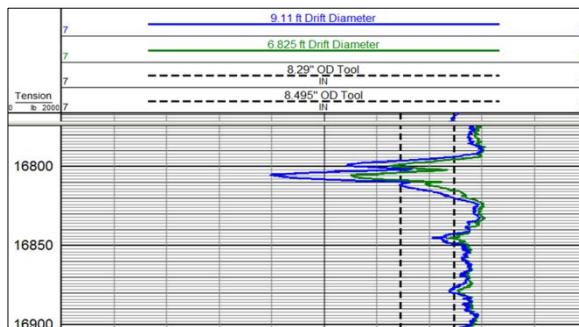
Drift diameter analysis that confirms neither the cleaning nor the suggested packer will fit through the buckle

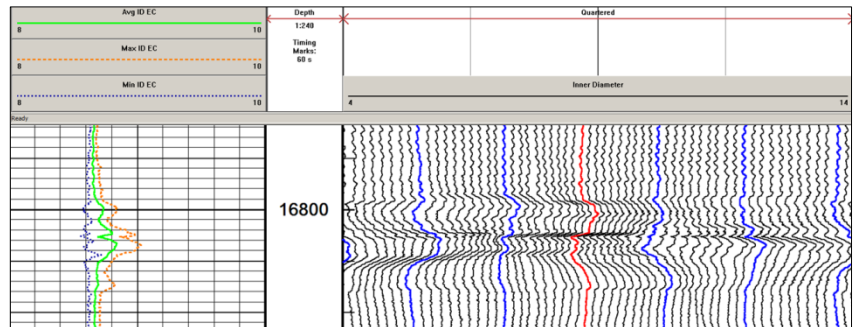
Log plot over troubled area

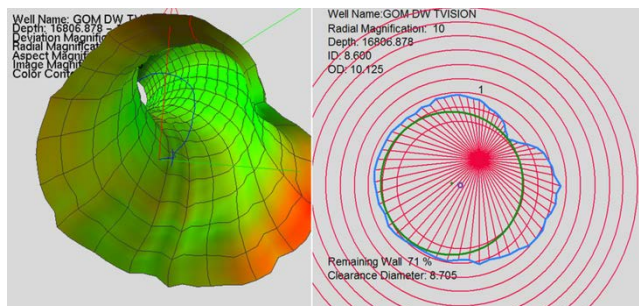
Possible wall loss inside deformation
