MetalSkin® Cased-Hole Liner System with Multi-Sensor Caliper (MSC™) Tool Identifies and Repairs Casing Damage, Enables Multiple Fracturing Stages

West Texas

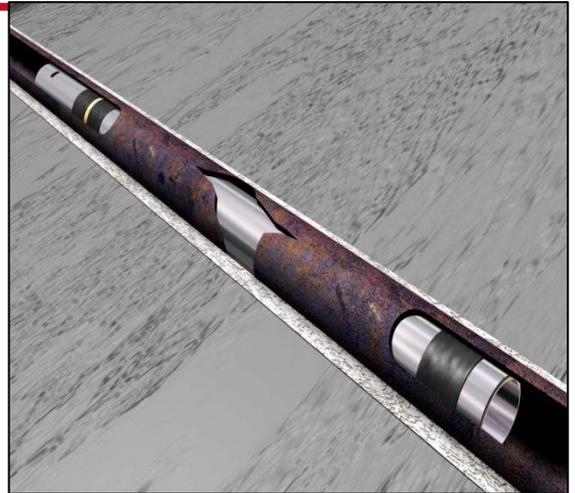
Multiple *MetalSkin* systems served as production packer seats and isolated damaged casing, enabling the well to be fractured in four to five stages for an increased production rate. As a result, Weatherford was awarded six additional jobs averaging 18 to 24 packer seats.
