# SecureView<sup>®</sup> Suite Pinpoints Casing Collar Split, Enables Recompletion of 50-Year-Old Well

LOCATION Netherlands

WELL TYPE Injection

CASING TYPE AND SIZE 7-in., 26/29 PPF

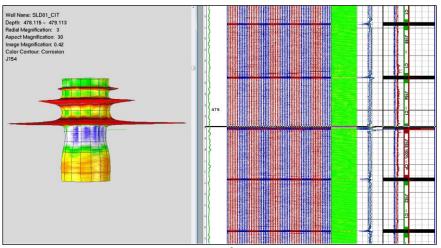
Processing data from the high-resolution Weatherford SecureView<sup>®</sup> suite produced the 3D presentation above indicating a casing collar defect in the mature well.

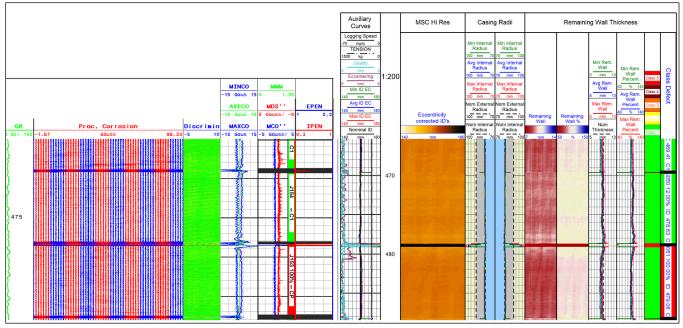
IES interpretation plots of CalView and FluxView data indicate casing defect near the collar at approximately 480.0 m MD.
