MetalSkin® Cased-Hole Liner System Enables Repairing Damaged Section and Restarting Production After Only 4 Days

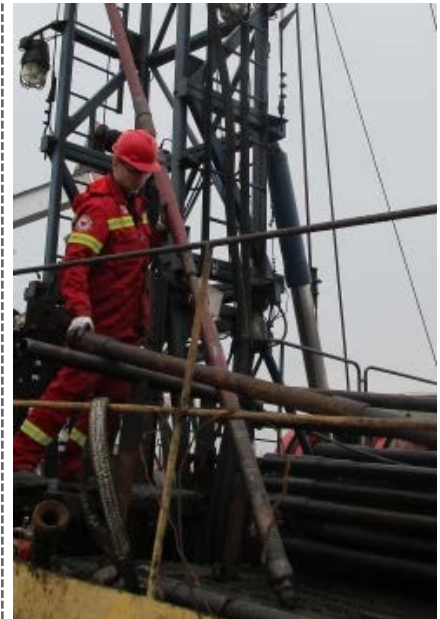
The crew ran the MetalSkin cased-hole liner expansion system into the well with minimal loss of inside diameter.
