MetalSkin® Cased-Hole Liner Patches Leaky Gas Well, Restores Production in Field with Major Pressure and Temperature Issues

MetalSkin® Cased-Hole Liner Patches Leaky Gas Well

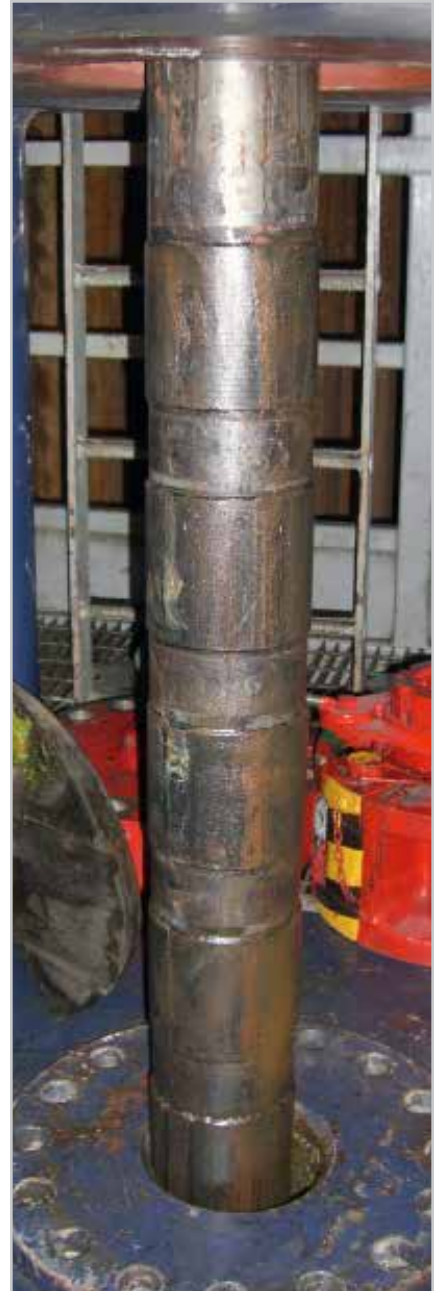
The MetalSkin system provided a long-term solution that repaired the leaky connection and restored production to its previous level.
