X-SPAN® Casing Patch

Restores Wellbore Integrity with Minimal Decrease in Internal Diameter to Achieve Greater Production

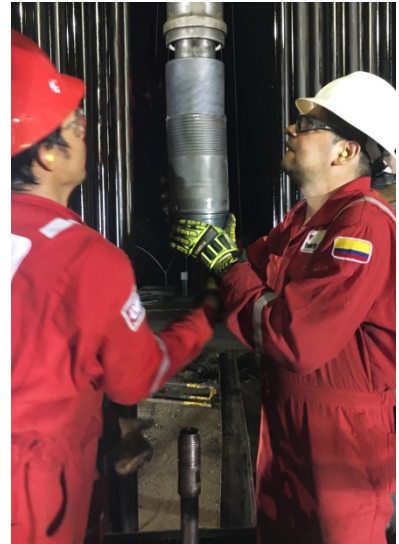
Working with a small workover rig, Weatherford casing integrity specialists in Colombia run the X-SPAN casing patch downhole to repair a section of damaged casing.

- After deploying a 162-ft (49.4-m) section of X-SPAN casing patch from 3,380 to 3,542 ft (1,030 to 1,080 m), they expanded the patch to restore casing integrity.
