# Weatherford®

### Casing Jacks, Custom-Built Work Beams Repair Damaged Casing Below Wellhead, Eliminate Need for Drilling Rig in Louisiana

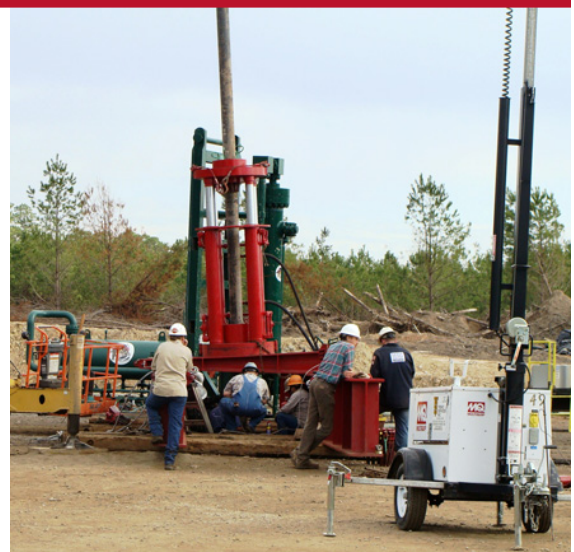
Weatherford's casing jacks and custom-built work beams are aligned with a bent casing to repair damage and bring a newly completed well back into production in Louisiana, USA.

- Weatherford personnel custom-designed a set of heavy-duty work beams to match the 12° angle of the bent casing, enabling the operator to safely extract the 5 1/2-in. and 7 5/8-in. casing in the well, above the 10 3/4-in. casing.
- The custom-built beams were placed under the casing jack, matching the angle of the bent casing, which enabled free travel of the hangers from the wellhead.
- The casing jacks and angle beams were rigged down to cut off the 10 3/4-in. casing head below the kink, and a new head was installed.
- The custom work beams were removed from the casing rig, and the 7 5/8-in. casing was rehung at the correct tension in a new casing hanger.
- After installing the next section of the wellhead, the 5 1/2-in. casing was rehung at the correct tension, and production at the well was restored.
