REAL RESULTS

Lead Seal Casing Patch Repairs Damaged Casing, Preserves Steam Injection Well, Eliminates Need to Drill Second Well

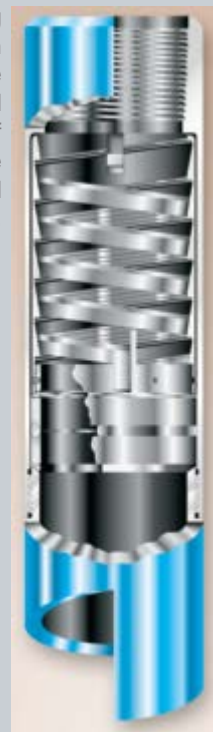
The lead seal casing patch is an external catch tool designed to engage a previously prepared fish, pack it off permanently and become a part of the repaired casing or tubing.

- Weatherford deployed a multistring cutter to cut the damaged part of the 9-5/8 in., 47-ft/lb (70-kg/m) buttress thread coupling (BTC) casing at 180 ft (54.8 m). The cut was dressed using a casing dress mill.
- When the top of the casing was in a good condition, Weatherford ran and set a lead seal casing patch in the wellbore.
- The lead patch was successfully installed despite the 350°F (176°C) wellbore temperature.
- A pressure test was conducted after the job, showing a good seal.
