REAL RESULTS

Weatherford Fishing and Re-Entry Services Enable Completion of Sidetrack, Recover 5,853 ft of Production Tubing

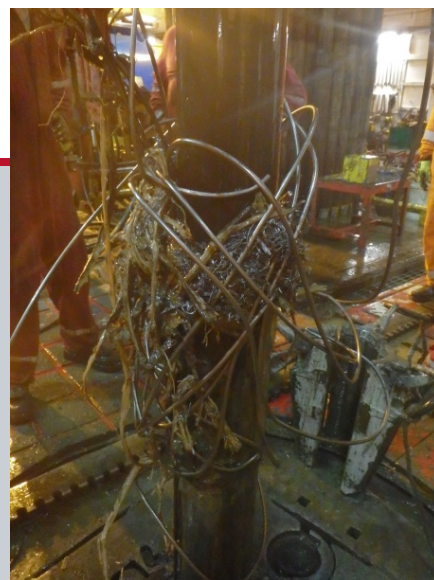
Using a combination of fishing and milling tools, Weatherford cleared a packed-off annulus and recovered a large string of production tubing.

- Weatherford deployed magnets followed by 8 3/8-in. concave and bladed junk-milling assemblies to mill the broken clamps, remove the obstruction from the annulus, and clear the area above and around the 5 1/2-in. production tubing.
- With the annulus cleared, Weatherford deployed an 8 1/8-in. FS S150 overshot to engage the remaining tubing and recover it to surface.
- With the fish and packing removed, the client was able to complete a cased-hole sidetrack at the desired depth.
