QuickCut ProSM Service Completes 20-in. Casing Exit, Enables Remote Collaboration That Saved 2 Trips in the North Sea

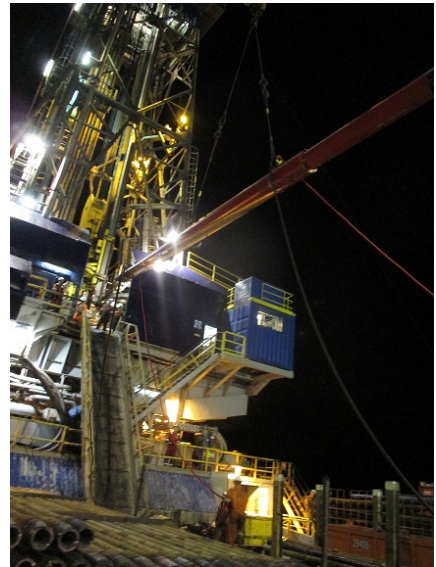
The Weatherford QuickCut Pro service, powered by the AccuView system, enabled real-time collaboration between an onsite Weatherford crew and an onshore team of Weatherford experts. This collaboration mitigated job risk and saved two trips out of hole.
