Intervention Innovation Prevents Abandonment of Onshore Exploration Well in Bolivian Field

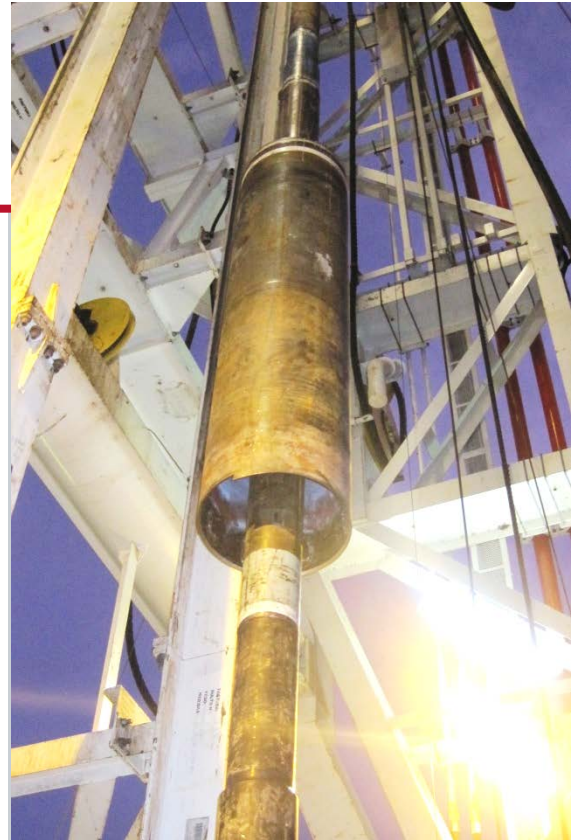
Weatherford fishing experts used a wide array of conventional and heavy-duty fishing tools to keep nonproductive time to a minimum. Their wealth of experience resulted in a custom casing patch that saved a high-value exploration well from abandonment.

- Weatherford's fishing team manufactured a custom mill suitable for correcting the large outer diameter (OD) of the casing and deployed it into the 8 1/2-in. well.
- A 24- x 20-in. casing patch with a joint 20-in. buttress was run through a 26-in. OD casing to 233 ft (71 m) measured depth (MD).
- The casing patch was tested, and a positive seal was confirmed.
