Mamba Severe-Service Coupling

Minimizes production-tubing wear and parted rod strings in erosive and corrosive rod-lift and PCP-lift wells

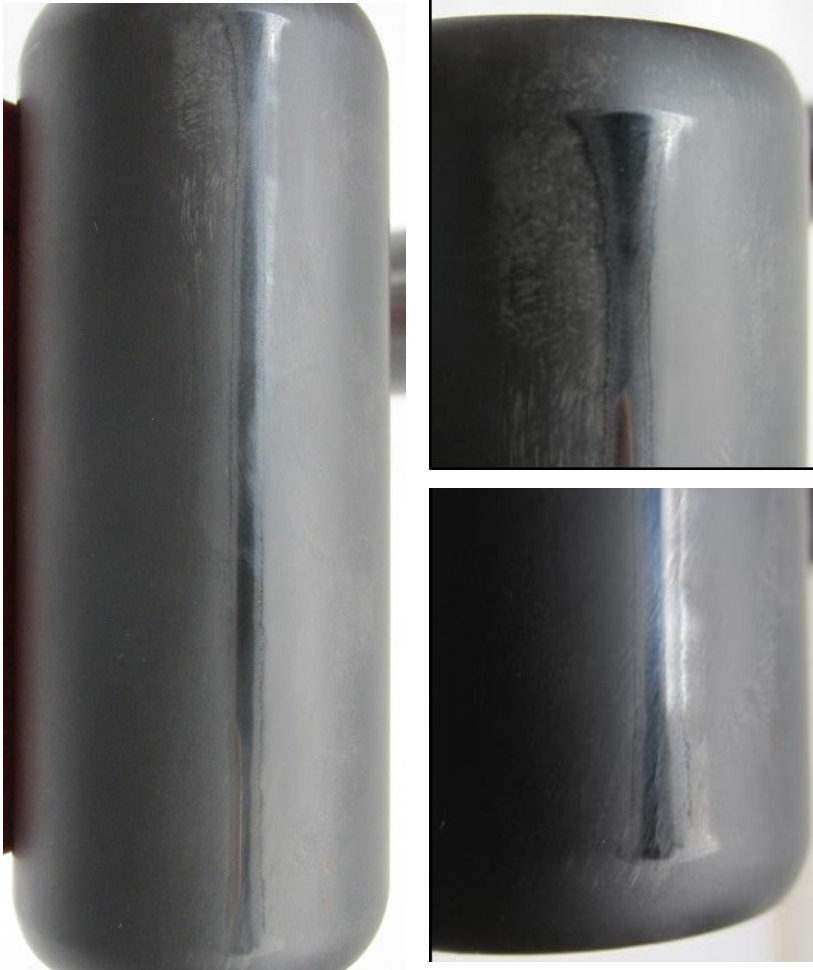
Coupling Wear Test Results

In laboratory wear tests, Mamba severe-service couplings show superior wear protection. Following 900,000 strokes with 60-lb. side pressure, Mamba couplings showed only a superficial wear path in sacrificial layer.

Laboratory tests show impeccable results following excruciating, 900,000-stroke run with 60 pounds of side-force. Only a superficial wear path is exposed through the sacrificial layer.

Wear location	Before	After	Difference
Top	1.8141 in. (46.08 mm)	1.8139 in. (46.07 mm)	0.0002 in. (0.005 mm)
Middle	1.8150 in. (46.1 mm)	1.8150 in. (46.1 mm)	0.0000 in. (0.0000 mm)
Bottom	1.8138 in. (46.07 mm)	1.8135 in. (46.06 mm)	0.0003 in. (0.0076 mm)

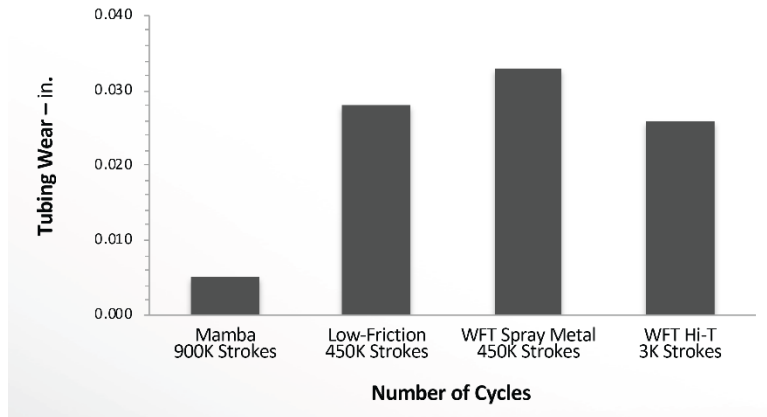
Tubing Wear Test Results

Laboratory tests conclude Mamba severe-service couplings preserved tubing IDs with superior protective properties. After 900,000 strokes with 60-lb. side pressure, Mamba couplings produced at least 10 times less wear following at least twice as many strokes.
