# Mamba Severe-Service Coupling

Minimizes production-tubing wear and parted rod strings in erosive and corrosive rod-lift and PCP-lift wells

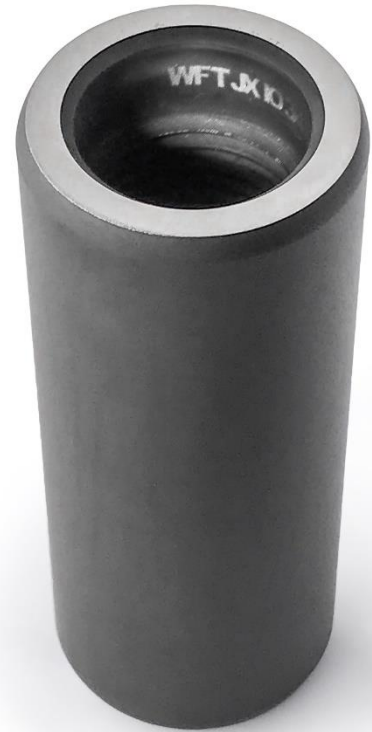
Mamba severe-service, sucker-rod couplings provide 6-times greater wear resistance compared to conventional or premium wear-resistant couplings in laboratory and field tests.

Compared to all previously available couplings—including standard, spray metal, and premium friction-resistant or softer-than-tubing base materials used in high-abrasion areas—the exclusive Mamba carbon-spray coating provides 6-times greater wear resistance and uptime in both laboratory and extensive field tests.

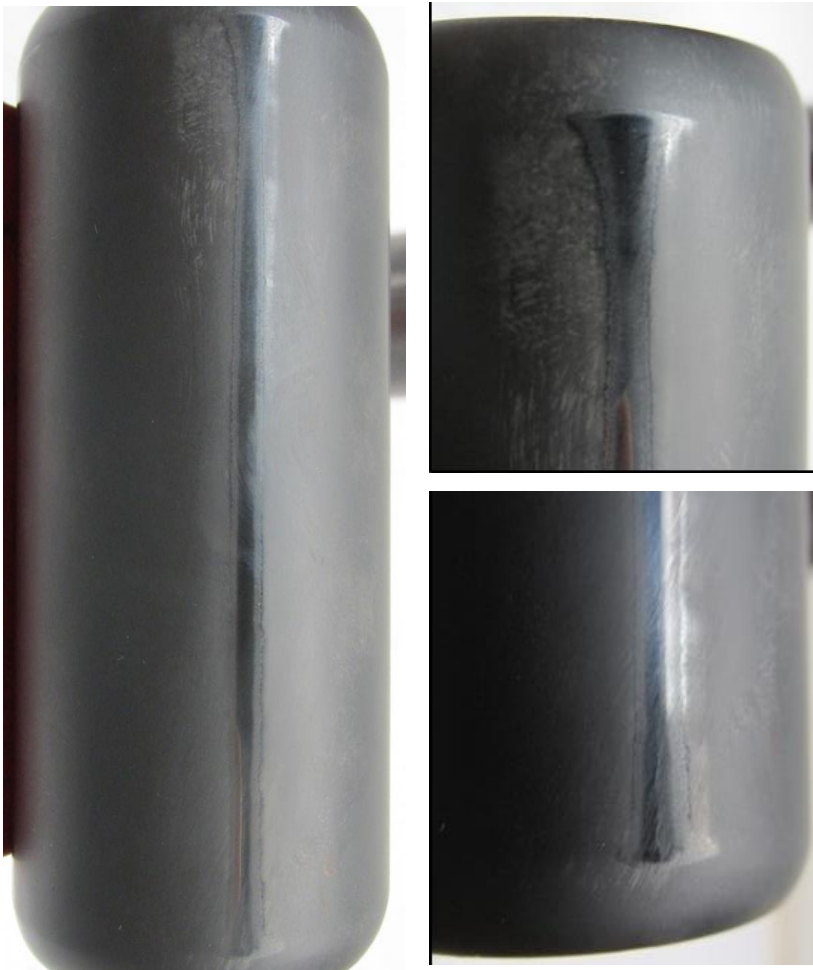
In laboratory wear tests, Mamba severe-service couplings show superior wear protection. Following 900,000 strokes with 60-lb. side pressure, Mamba couplings showed only a superficial wear path in sacrificial layer.

Laboratory tests show impeccable results following excruciating, 900,000-stroke run with 60 pounds of side-force. Only a superficial wear path is exposed through the sacrificial layer.

Wear location	Before	After	Difference
Top	1.8141 in. (46.08 mm)	1.8139 in. (46.07 mm)	0.0002 in. (0.005 mm)
Middle	1.8150 in. (46.1 mm)	1.8150 in. (46.1 mm)	0.0000 in. (0.0000 mm)
Bottom	1.8138 in. (46.07 mm)	1.8135 in. (46.06 mm)	0.0003 in. (0.0076 mm)

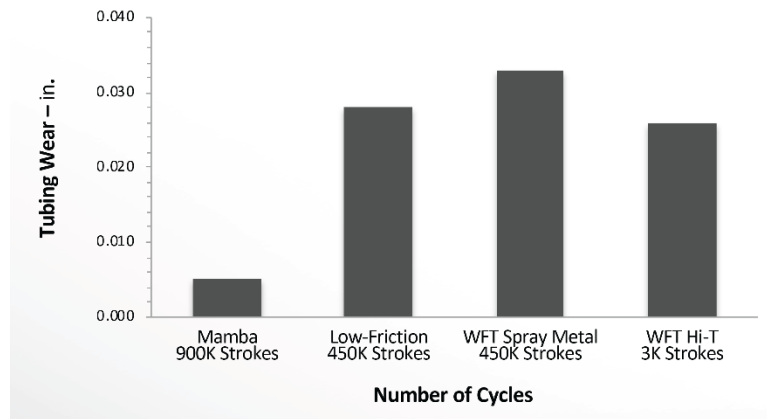
Laboratory tests conclude Mamba severe-service couplings preserved tubing IDs with superior protective properties. After 900,000 strokes with 60-lb. side pressure, Mamba couplings produced at least 10 times less wear following at least twice as many strokes.
