Advanced Openhole Logs Helped to Recognize Unexpected Fault With Lack of Seismic Data, Enabled Adjustment of Fracking Operation

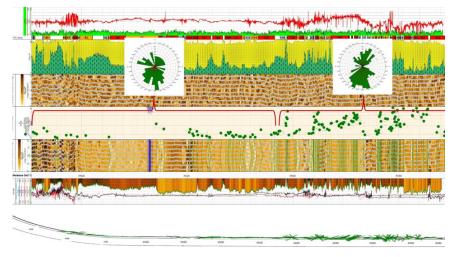
The dip angle of the bedding is quite low in the upper interval. In the lower interval, the bedding dip angle became high and variated drastically along the borehole. The anisotropy azimuth was diverged in a horizontal direction in the lower interval, indicating the angle off from the borehole and formation. The primary azimuth of the bedding is south while the secondary is north, indicating that the strike of the fold and fault is west-east.

- In addition, the analysis examined pick dip features like bedding, induced fracture, and resistive fracture along the horizontal via borehole image.
- Analysis of the bedding dips showed the front section of the borehole with a low dip angle, but at the tail of the hole, the variation was dramatic. This discovery indicated the borehole was penetrated into some folds and faults, which was unexpected, as the seismic data was unavailable.
- The anisotropy analysis in this section corresponded to this abnormality: the fast azimuth was not in a horizontal direction, which is theoretical when the borehole is parallel to the formation.
