Weatherford®

REAL RESULTS

MetalSkin® Cased-Hole Liner System Helps Repair Damaged Casing, Quickly Returns Well to Production

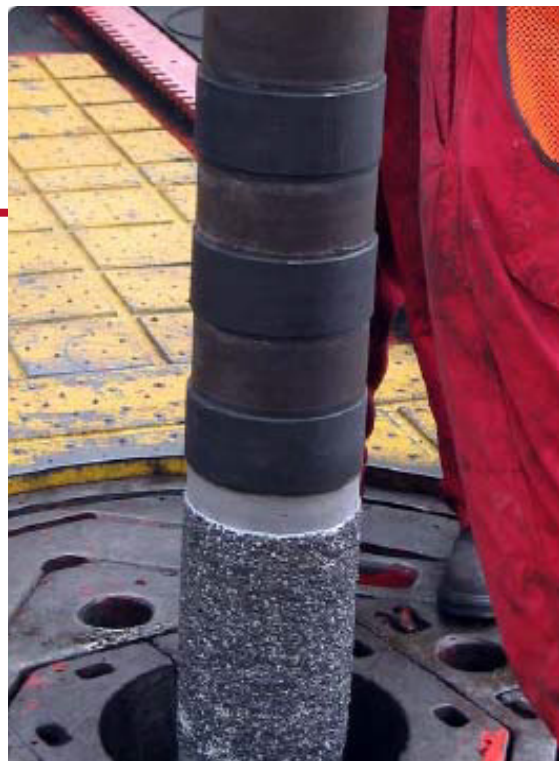
Weatherford's *MetalSkin* cased-hole liner system provides a permanent, cost-effective solution, isolating and sealing unwanted perforations for increased production capacity.
