SecureView® Service and MetalSkin® Liner

Diagnose and Permanently Restore Casing Integrity, Save \$120 million in Out-of-Service Costs

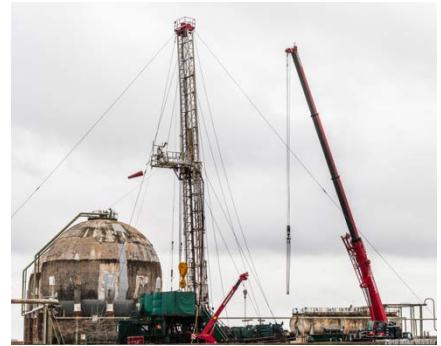
A multidisciplinary Weatherford team diagnosed casing corrosion and then restored casing integrity to an ethylene storage well. The operation saved the client weeks of out-of-service time and costs.
