Colombia: MetalSkin® System Seals Off Water-Producing Zone, Enables Optimal Production in 24 Hours

Meta Petroleum

Onshore Colombia

Rubiales field

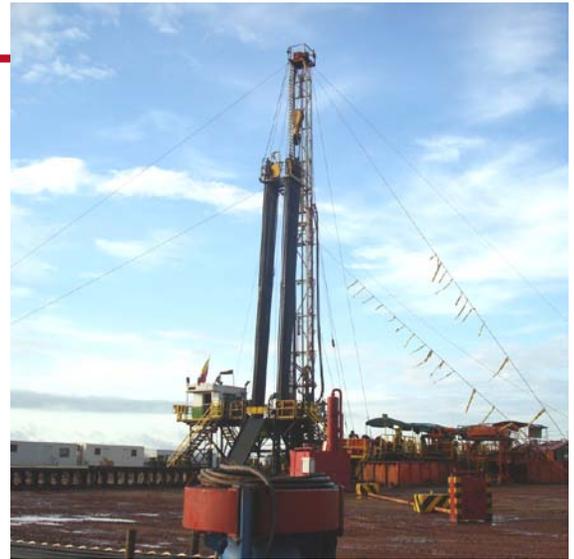
The *MetalSkin* cased-hole liner system incorporates solid expandable technology and other advanced design features to optimize a wide range of well remediation procedures, including casing repair. It minimizes slimming of the well profile post-repair, reducing costs and facilitating access to deeper zones—critical in the event that additional remediation procedures become necessary. As such, it presents an attractive alternative to cement squeezes, scab liners, and straddle-packer assemblies.

- Weatherford installed its 5 1/2-in. x 7-in. *MetalSkin* cased-hole liner system to successfully case off the window while maintaining an ID large enough to allow perforating and producing the zone directly below the cased-off window.
- Weatherford executed the job in only 24 hr. During that time, the setting tool and the 40 ft (12 m) of expandable 5 1/2-in. liner were run to total depth, where the liner was expanded into the host casing and pressure-tested. The post-expansion liner successfully sealed off the casing window with minimal loss of hole size.
- After installation, the expanded 5 1/2-in. liner produced a drift of 5.458 in., providing the client with enough clearance to run an optimal size production string.
